**WEST DIKE  
ARLINGTON MILL RESERVOIR  
NH 00029**

**PHASE I INSPECTION REPORT  
NATIONAL DAM INSPECTION PROGRAM**

**AUGUST 1978**

Name of Dam West Dike, Arlington Mill Reservoir  
State Located New Hampshire  
County Located Rockingham  
City or Town Salem  
Stream Spicket River  
Date of Inspection 6/7/78 and 6/28/78

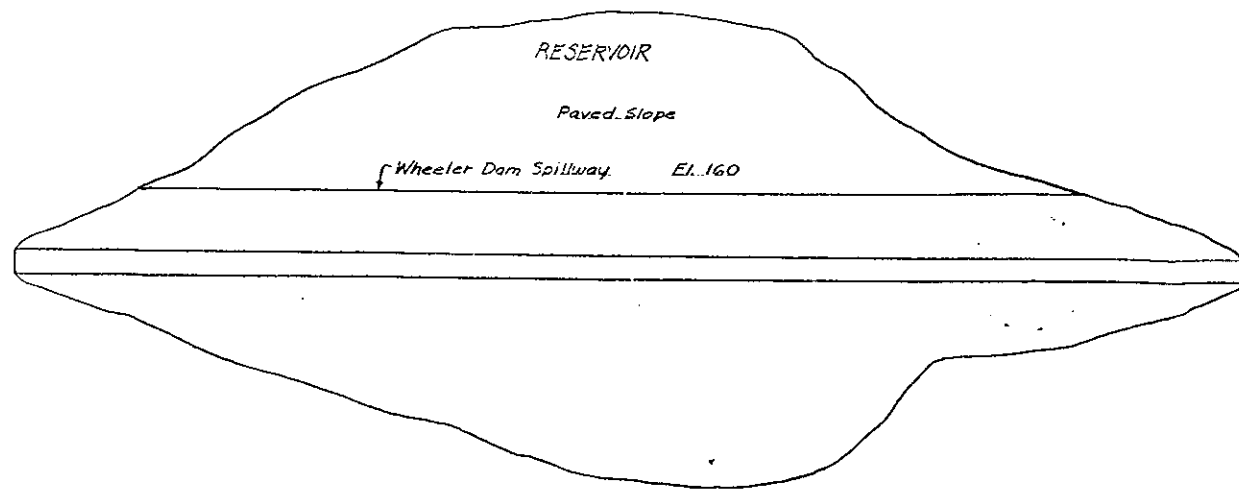
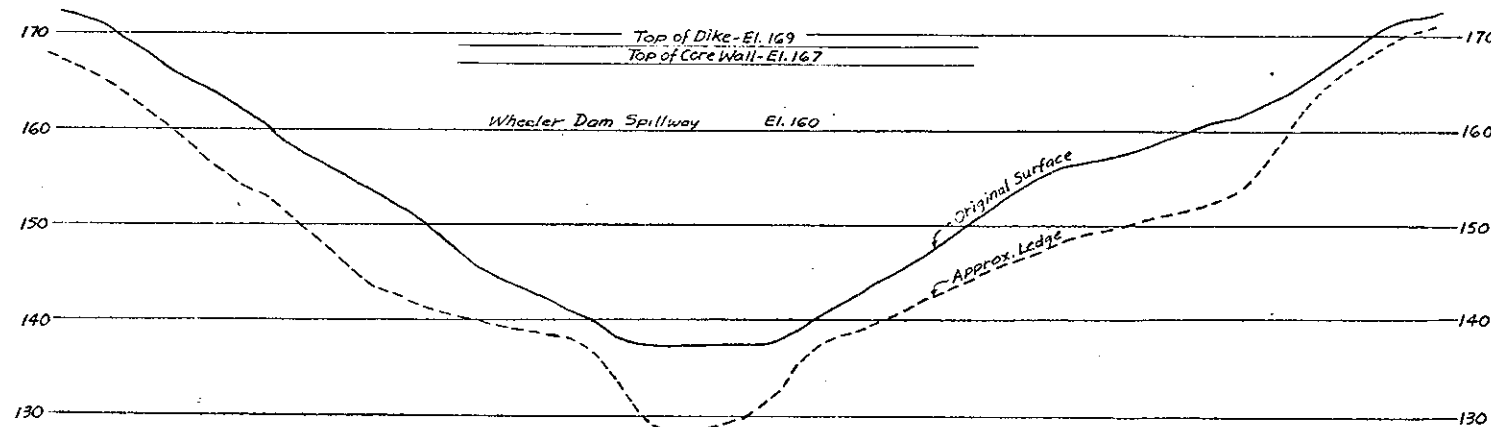
Plans show the West Dike was designed as a homogeneous embankment placed on natural ground after the surface had been stripped of loam and mud. The plans show a small trench, several feet wide and several feet deep and containing "impervious fill" where needed, cut into the natural ground along the centerline of the dike. The drawing shows that this trench did not extend to "ledge" (bedrock). The drawing also shows that the upstream slope of the dike was to be riprapped, but it has since been covered with beach sand. No other information is available about the foundations or the design of the embankment. See Plate in Appendix B.
